### Inspection Report Minerals Regulatory Program June 1, 2010

<b>Mine Name:</b> ML 48945	<b>Permit Number:</b> S/027/0103
<b>Operator Name:</b> Drachuk, Robert D.	<b>Inspection Date:</b> 05/13/2010
<b>Inspector(s):</b> Brett Gregory for John Rogers	<b>Time:</b> 3:00 pm
<b>Other Participants:</b> None	<b>Mine Status:</b> Active

#### Inspection Summary:

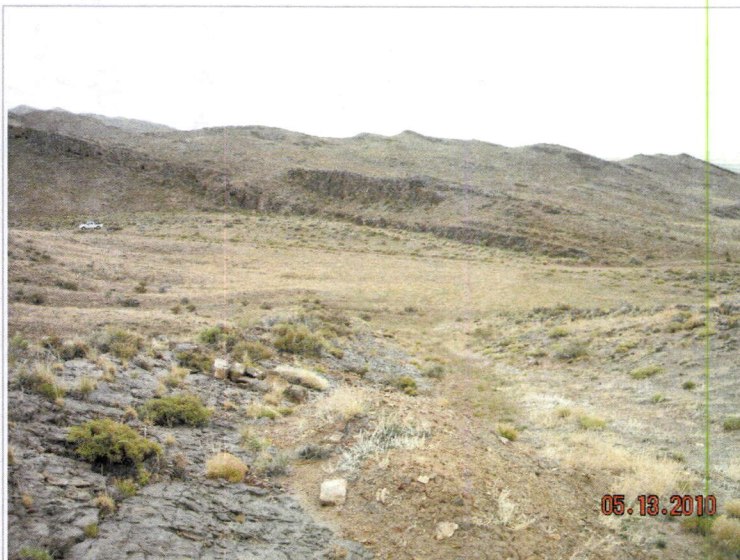
Access path leading up to the northern disturbance.

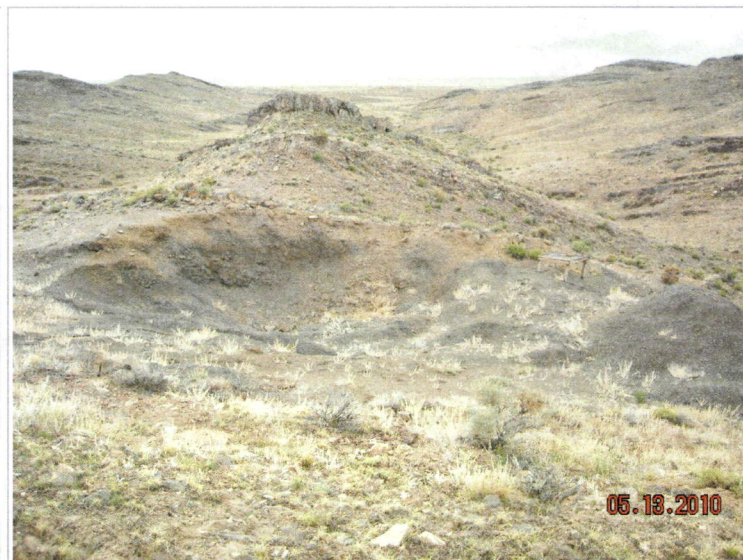
Northern disturbance.

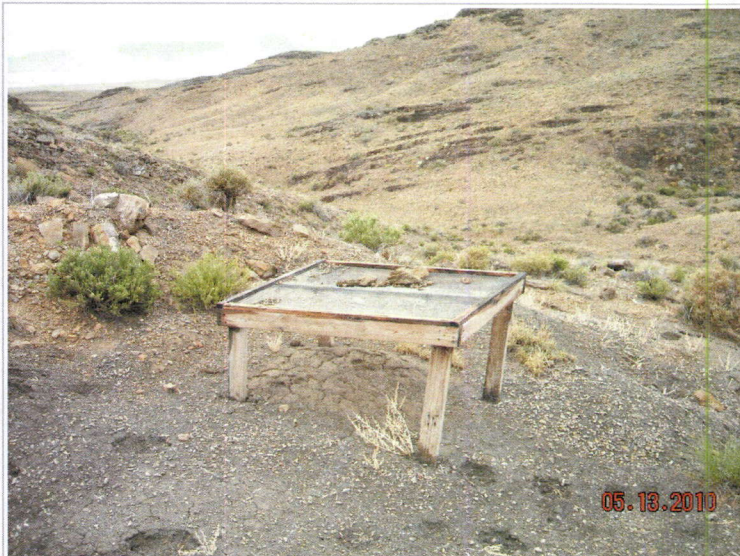
Sifting screen.

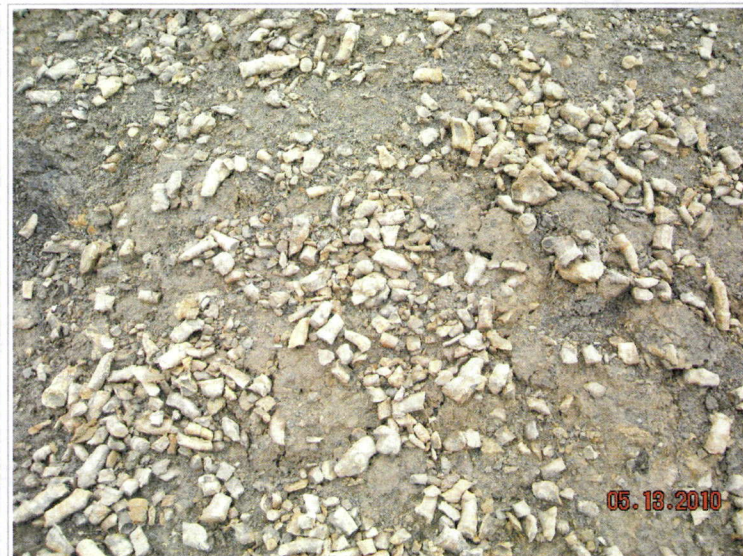
Horn Coral product being extracted.

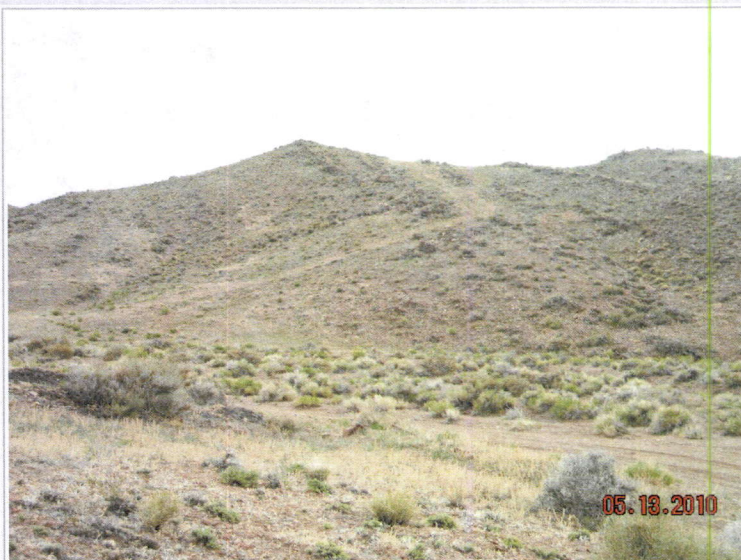
One of two access roads used to access the southern disturbance.

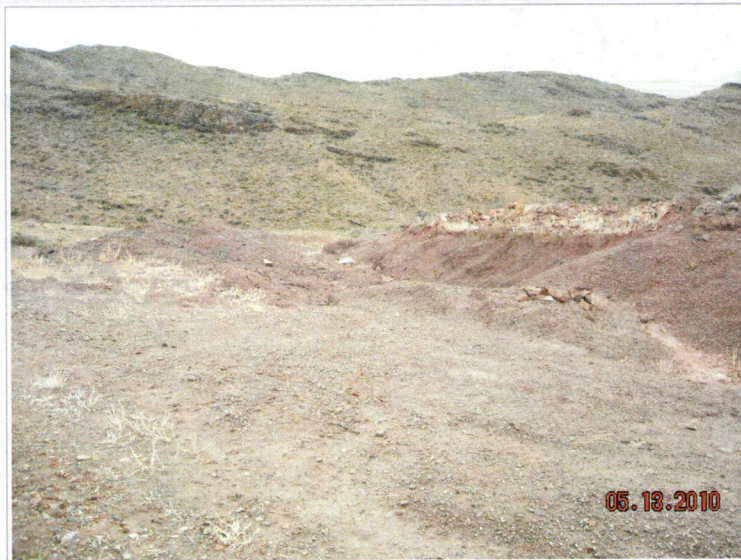
Top of southern disturbance looking south.

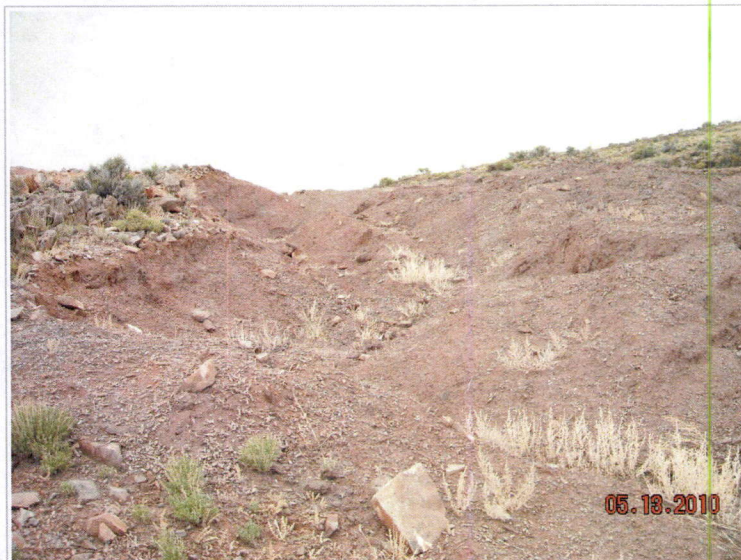
Bottom of southern disturbance looking north.

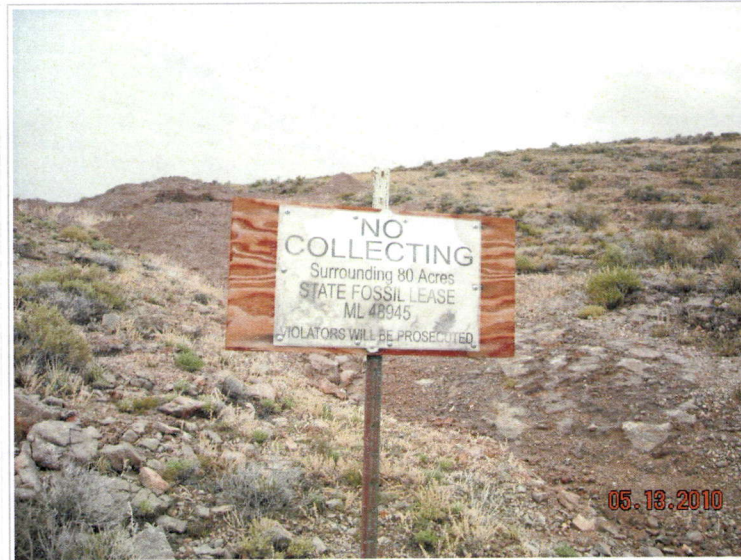
Posted mining lease.
